DYNAMIC SCIENCE, INC.
In-Depth Crash Investigation

Contract DTNH22-94-D-27058
Case DSI-96-AB-09

DYNAMIC SCIENCE, INC.
CRASH INVESTIGATION
CASE NUMBER: DS9609

This case was initiated in response to a report of airbag-related serious head injuries to a child in the right front passenger seat.

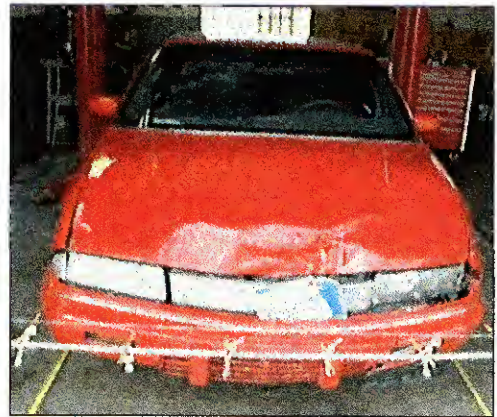
Figure 1. Vehicle 1, 1995 Pontiac Grand Prix

As Vehicle 1 approached the intersection, traffic in the adjacent two lanes was stopped. There was a break in traffic for those cars west of the intersection and east of the intersection and they allowed Vehicle 2 to begin his left hand turn. The driver of Vehicle 1 indicated that she saw Vehicle 2 enter the lane and braked. As Vehicle 2 entered the southernmost travel lane it was struck in the right front by the left front of Vehicle 1. Both airbags in Vehicle 1 deployed at this time. The computed delta V was 8 MPH, while the maximum possible delta V was determined to be 13 MPH (based on data from the on-board diagnostic module).

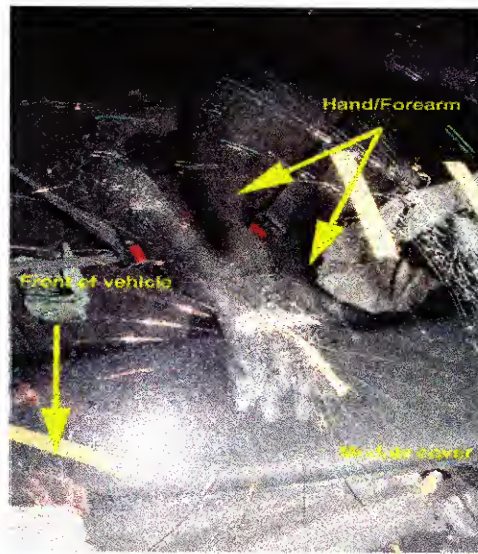
Figure 2. Windshield contact/right hand

some degree--the right front passenger more so since he was not wearing the shoulder portion. The right front passenger rotated over the lap belt and went forward to a sufficient degree that his right hand was above the airbag module. At deployment, the driver engaged the airbag fully and did not sustain any injuries. The right front occupant's right hand was trapped between the airbag module cover and the windshield at deployment. His face was struck by the not-fully-deployed airbag. He was then pushed upward and backward. It is not known where he initially came to rest. There is evidence that the left side of his head was lying on the center console/armrest, but the driver may have pulled him towards her.

about as a result of contact with the airbag. The right hand and upper arm injuries resulted from the occupant's hand becoming trapped between the module cover and the windshield during deployment.

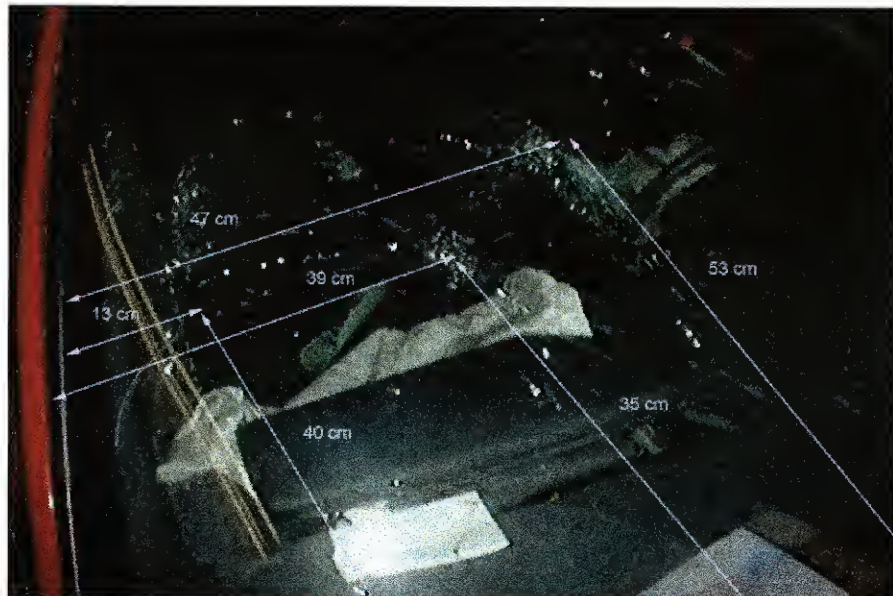
Figure 4. Windshield damage measurements

The right front airbag is 60 cm wide. The module cover is attached to the instrument panel with a nylon strap. At deployment, the module cover will lift up and strike the windshield--as it did in this case. A small metal fragment was found embedded in the fabric of the airbag.

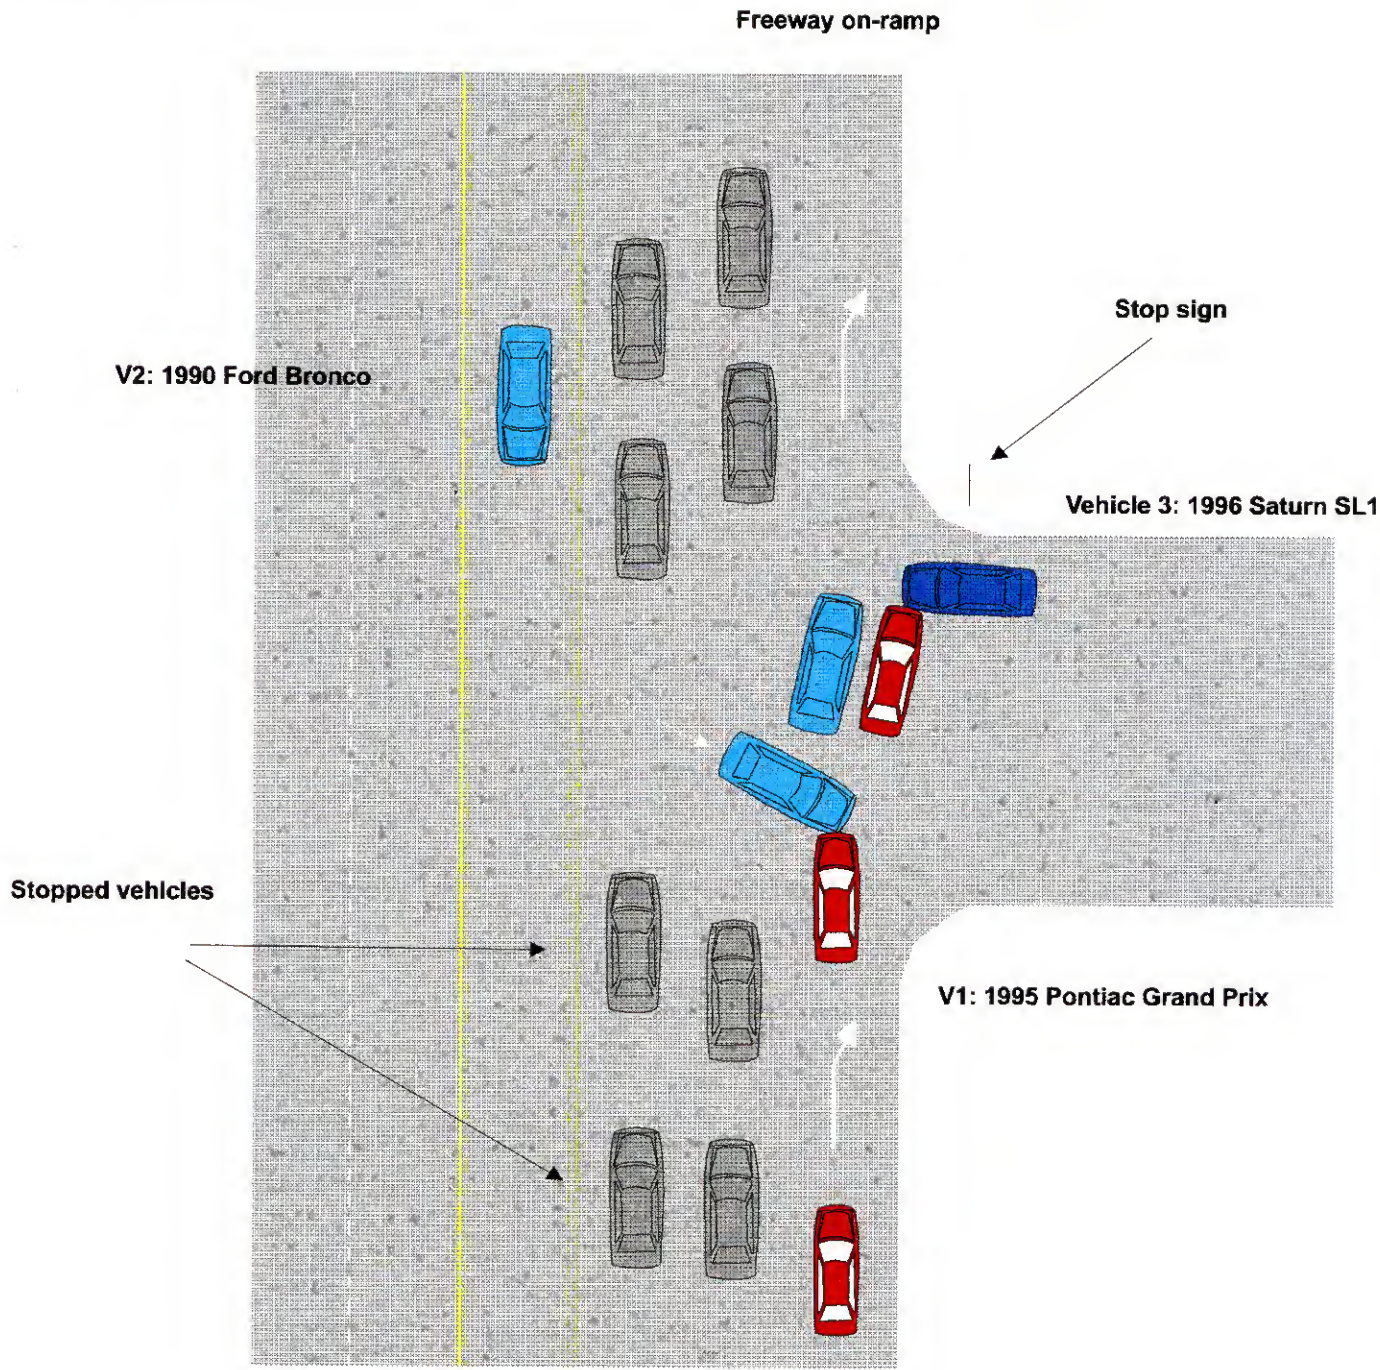
ACCIDENT DIAGRAM

Scale: 1" = 20'

DATA POINT	LONGITUDINALS	LATERALS
Lane 1 (right turn)	0	4.26 M (14 ft.) NRL
Lane 2	0	7.8 M (25.6 ft.) NRL
Lane 3	0	11.3 M (38.2 ft.) NRL
Lane 4	0	16.09 M (52.8 ft.) NRL
Lane 5	0	19.9 M (65.3 ft.) NRL
Lane 6	0	23.4 M (76.8 ft.) NRL
Northbound roadway	12.19 M (40 ft.) ERP	0
Final rest V1		
LF	(1 ft.) NRP	(30 ft.) ERL
LR	(4 ft.) NRP	(21 ft.) ERL
Final rest V2		
LF	(9.6 ft.) NRP	(33 ft.) ERL
LR	(13.6 ft.) NRP	(25.5 ft.) ERL
Final rest V3		
LF	(3.6 ft.) SRP	(32 ft.) ERL
LR	(12 ft.) SRP	(31 ft.) ERL
